# Hydrologic alteration and riparian vegetation in Spain

# Riparian corridor restoration and flood policy in Scotland

Roberto Martinez
Senior Hydromorphologist - SEPA
Belgrade, Serbia, 4-5 Sept 2019

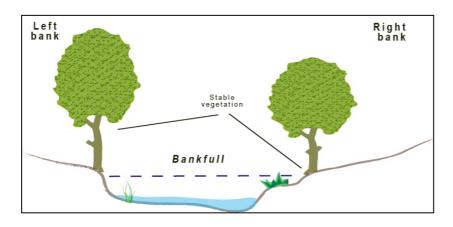
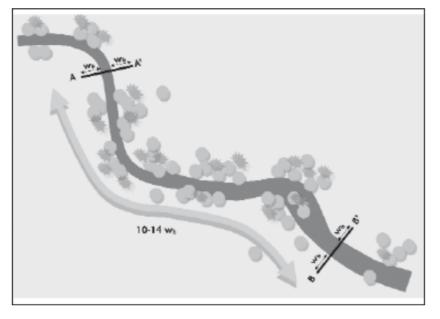
### Riparian Index: RFV

Clasificación	
RFV Longitudinal	5 clases	
RFV Transversal	5 clases	
RFV Structure	5 clases	
RFV regeneration	5 clases	
RFV aggregated	5 clases

5 clases:
High →Good → Moderate →Poor → Bad
(5) (4) (3) (2) (1)

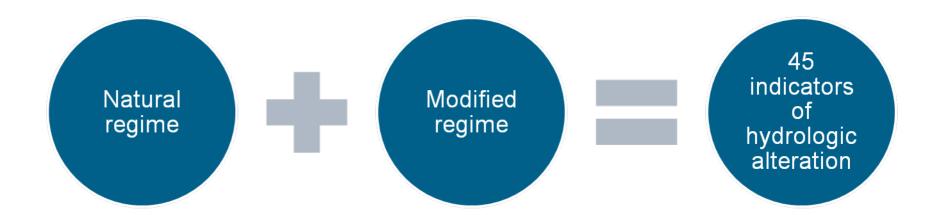
### **IAHRIS:** Hydrologic alteration

Software: http://ambiental.cedex.es/hidromorfologia-iahris.php

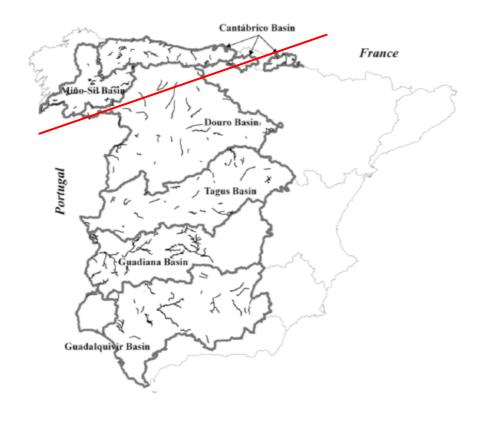
### Study area (mostly Mediterranean)

Cuenca	Masas agua (Alt. Hidrológ.)	Masas agua (RFV)
Cantábrico	8	31
Miño-Sil	9	24
Guadalquivi r	21	32
Guadiana	4	23
Duero	23	40
Tajo	22	32
Total	87	182

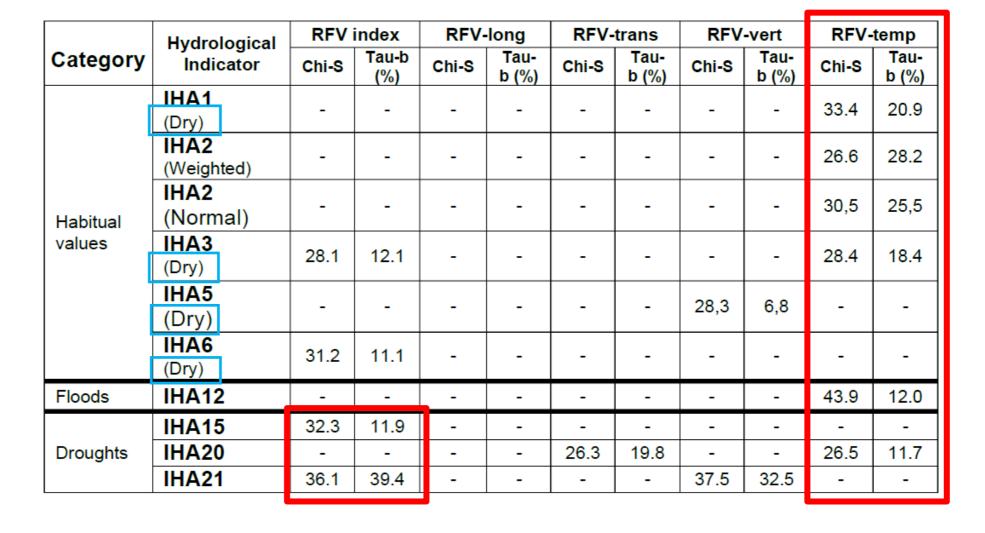
### Statistical comparison: IHA and RFV

- The **regeneration of the riparian forest** is the most sensitive component to the hydrologic alteration. (low flows, droughts and floods).
- Management of flows during dry periods and drought is key to minimise the impact of flow regulation on the status of riparian vegetation.
- The longitudinal component (first band) of the riparian vegetation is not significantly altered. There is not severe impacts from regulated flows. Two reasons could be associated with this (i) Spanish regulation via Hydraulic Public Domain (MMA, 2008), protecting this space from human activities, and (ii) the first band of riparian vegetation is more resilient to different stressors due to its proximity to water.

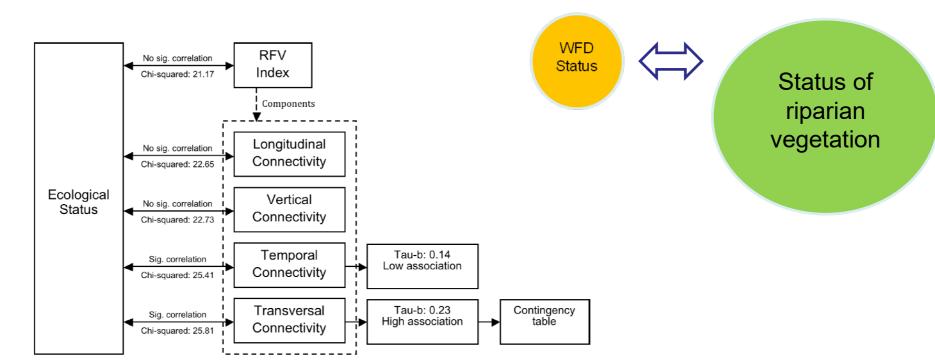
There is a lack of significant relationship between the WFD ecological status and the status of the riparian vegetation (only transversal component is correlated).

Figure 1 Results of the statistical analysis: correlations between ecological status and status of riparian vegetation.
